**VATTEROTT LAKE DAM
JEFFERSON COUNTY, MISSOURI
MO 30429**

PHASE 1 INSPECTION REPORT NATIONAL DAM SAFETY PROGRAM

MARCH 1981

PHASE 1 INSPECTION REPORT
NATIONAL DAM SAFETY PROGRAM
VATTEROTT LAKE DAM - MO 30429

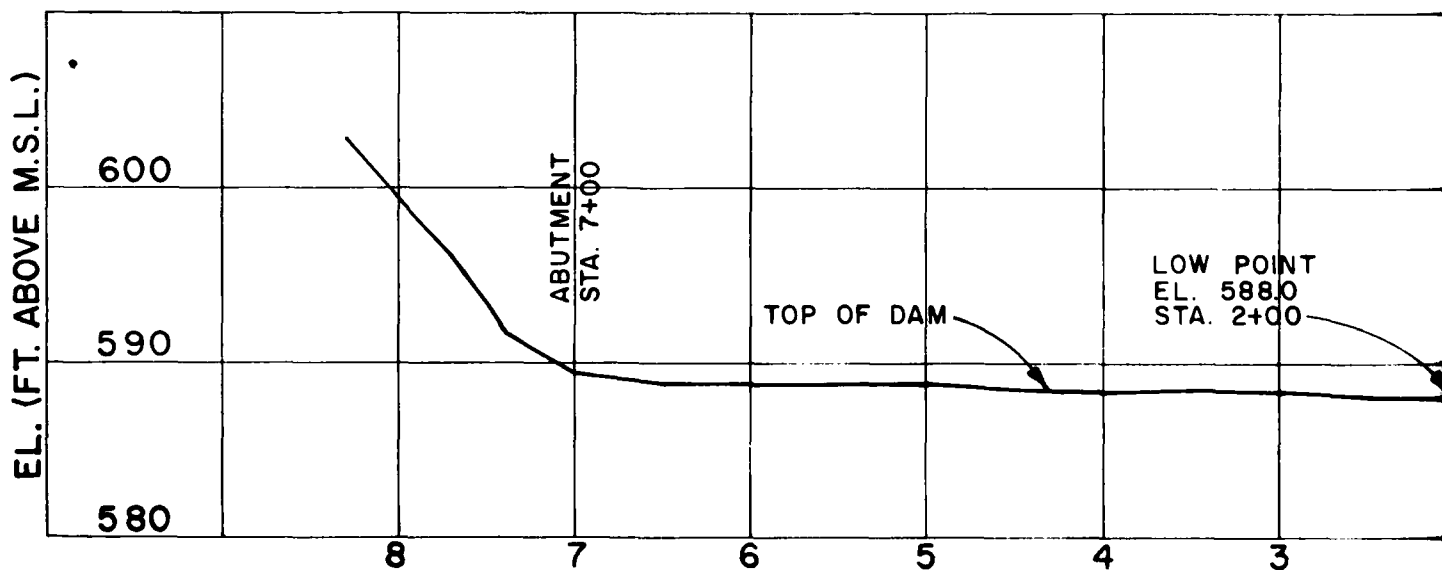
PROFILE DAM CREST

According to survey data obtained during the inspection, the top of the dam in the vicinity of the original stream crossing was found to be approximately 0.9 foot lower than the top of the dam at its highest point. It is possible that the dam has experienced some settlement, particularly through the area of the original stream location.

extent of possible future settlement and the remedial work required to compensate for such settlement. In any event, the crest of the dam should be uniform throughout without low areas that reduce dam freeboard and penalize spillway capacity. It should be noted that the low point of the top of the dam was found to be only 0.4 foot higher than the crest of the emergency spillway.
